Possible Aerosol Transmission of COVID-19 Associated with an Outbreak in an Apartment in Seoul, South Korea, 2020

Perspective

The study: We investigated the epidemiological relationship among infected cases on a recent

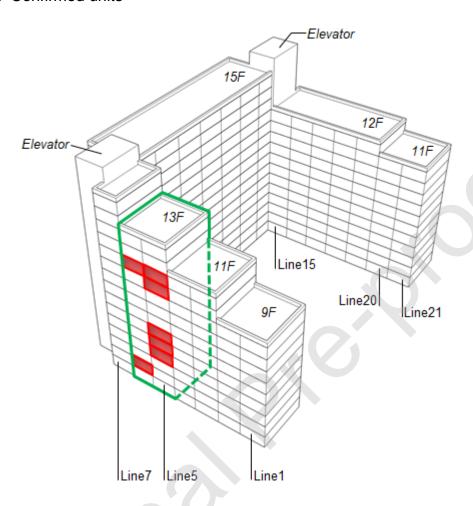
A. Confirmed units

Figure 1. Structure of the apartment building where the infection outbreaks occurred in two vertical line

The apartment where the outbreak occurred was built in 1988 and consisted of 9 to 15 floors. Fifteen to twenty-one households are living along the hallway on each floor. Two elevators and entrances are located at both corners of the building (Figure 1). In this apartment, a natural ventilation shaft is located along each vertical line from the bottom to the rooftop. Each shaft is connected to the units within the same vertical line through the blowhole at the bathroom (Figure 2).

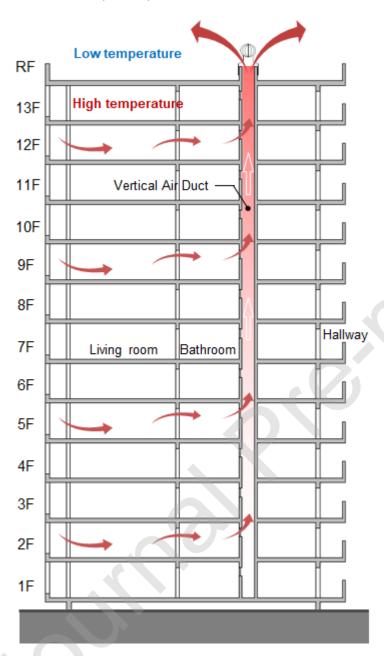
A. Stack effect (winter)

Figure 2. Diagram of the airflow in the air duct

The apartment is vertically connected with a shaft through blowholes at the bathroom. Besides, units do not have a fan because this building was built before the installation of an exhaust fan with a backdraft damper in bathrooms became compulsory. Thus, there is no physical block for the air entering the room from the air duct. This structure can easily make a stack effect that refers to the vertical movement caused by the difference in indoor and outdoor air density due to the difference in temperature inside and outside the building. In this case, patient no. 7 from the 10th floor, whose symptom appeared first, is suspected as the infection source in this cluster, which means that the infection may have spread from the 10th floor to the upper floors and mainly downstairs. The direction of air movement in the vertical space varies depending on the season. In summer, since the temperature inside is lower and the density is higher than the outside, the air inside the building moves to the lower part by receiving a downward force; this is called the reverse stack effect (Mijorski and Cammelli,
